**Enbridge Line 6B MP 608 Pipeline Release
Marshall, Michigan**

**Permanent Recovery of Submerged Oil and Oil-Contaminated
Sediments at Priority Locations**

Submerged Oil Recovery Summary Report

**Enbridge Energy
October 29, 2010**

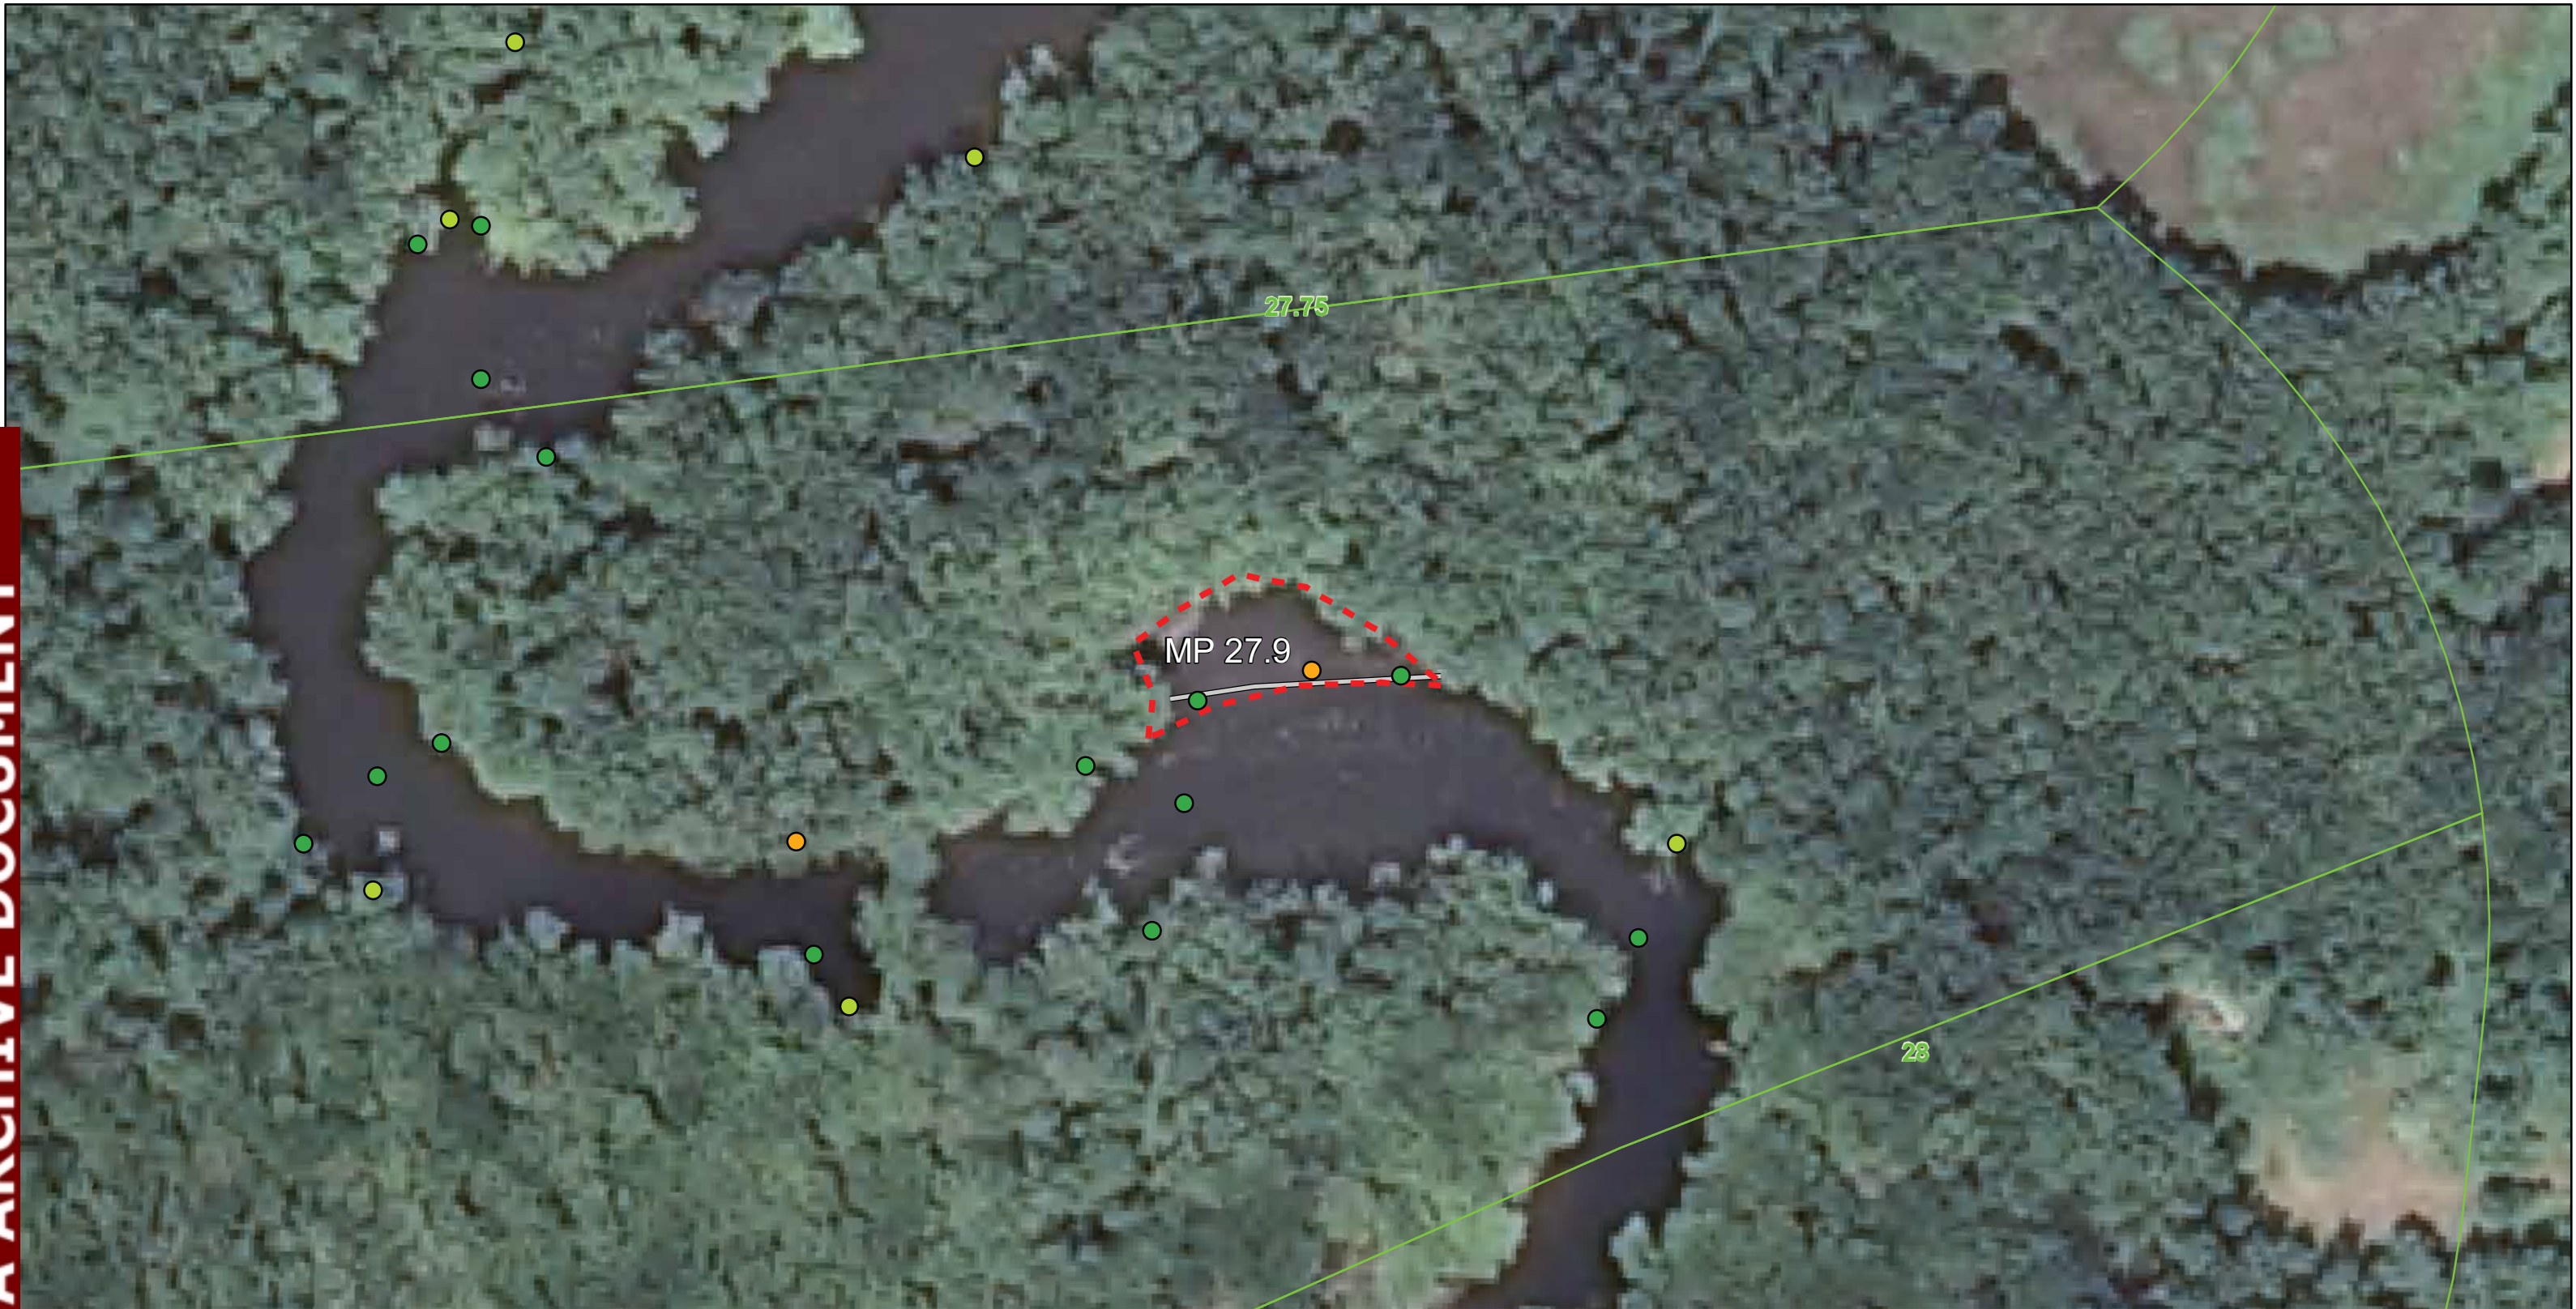
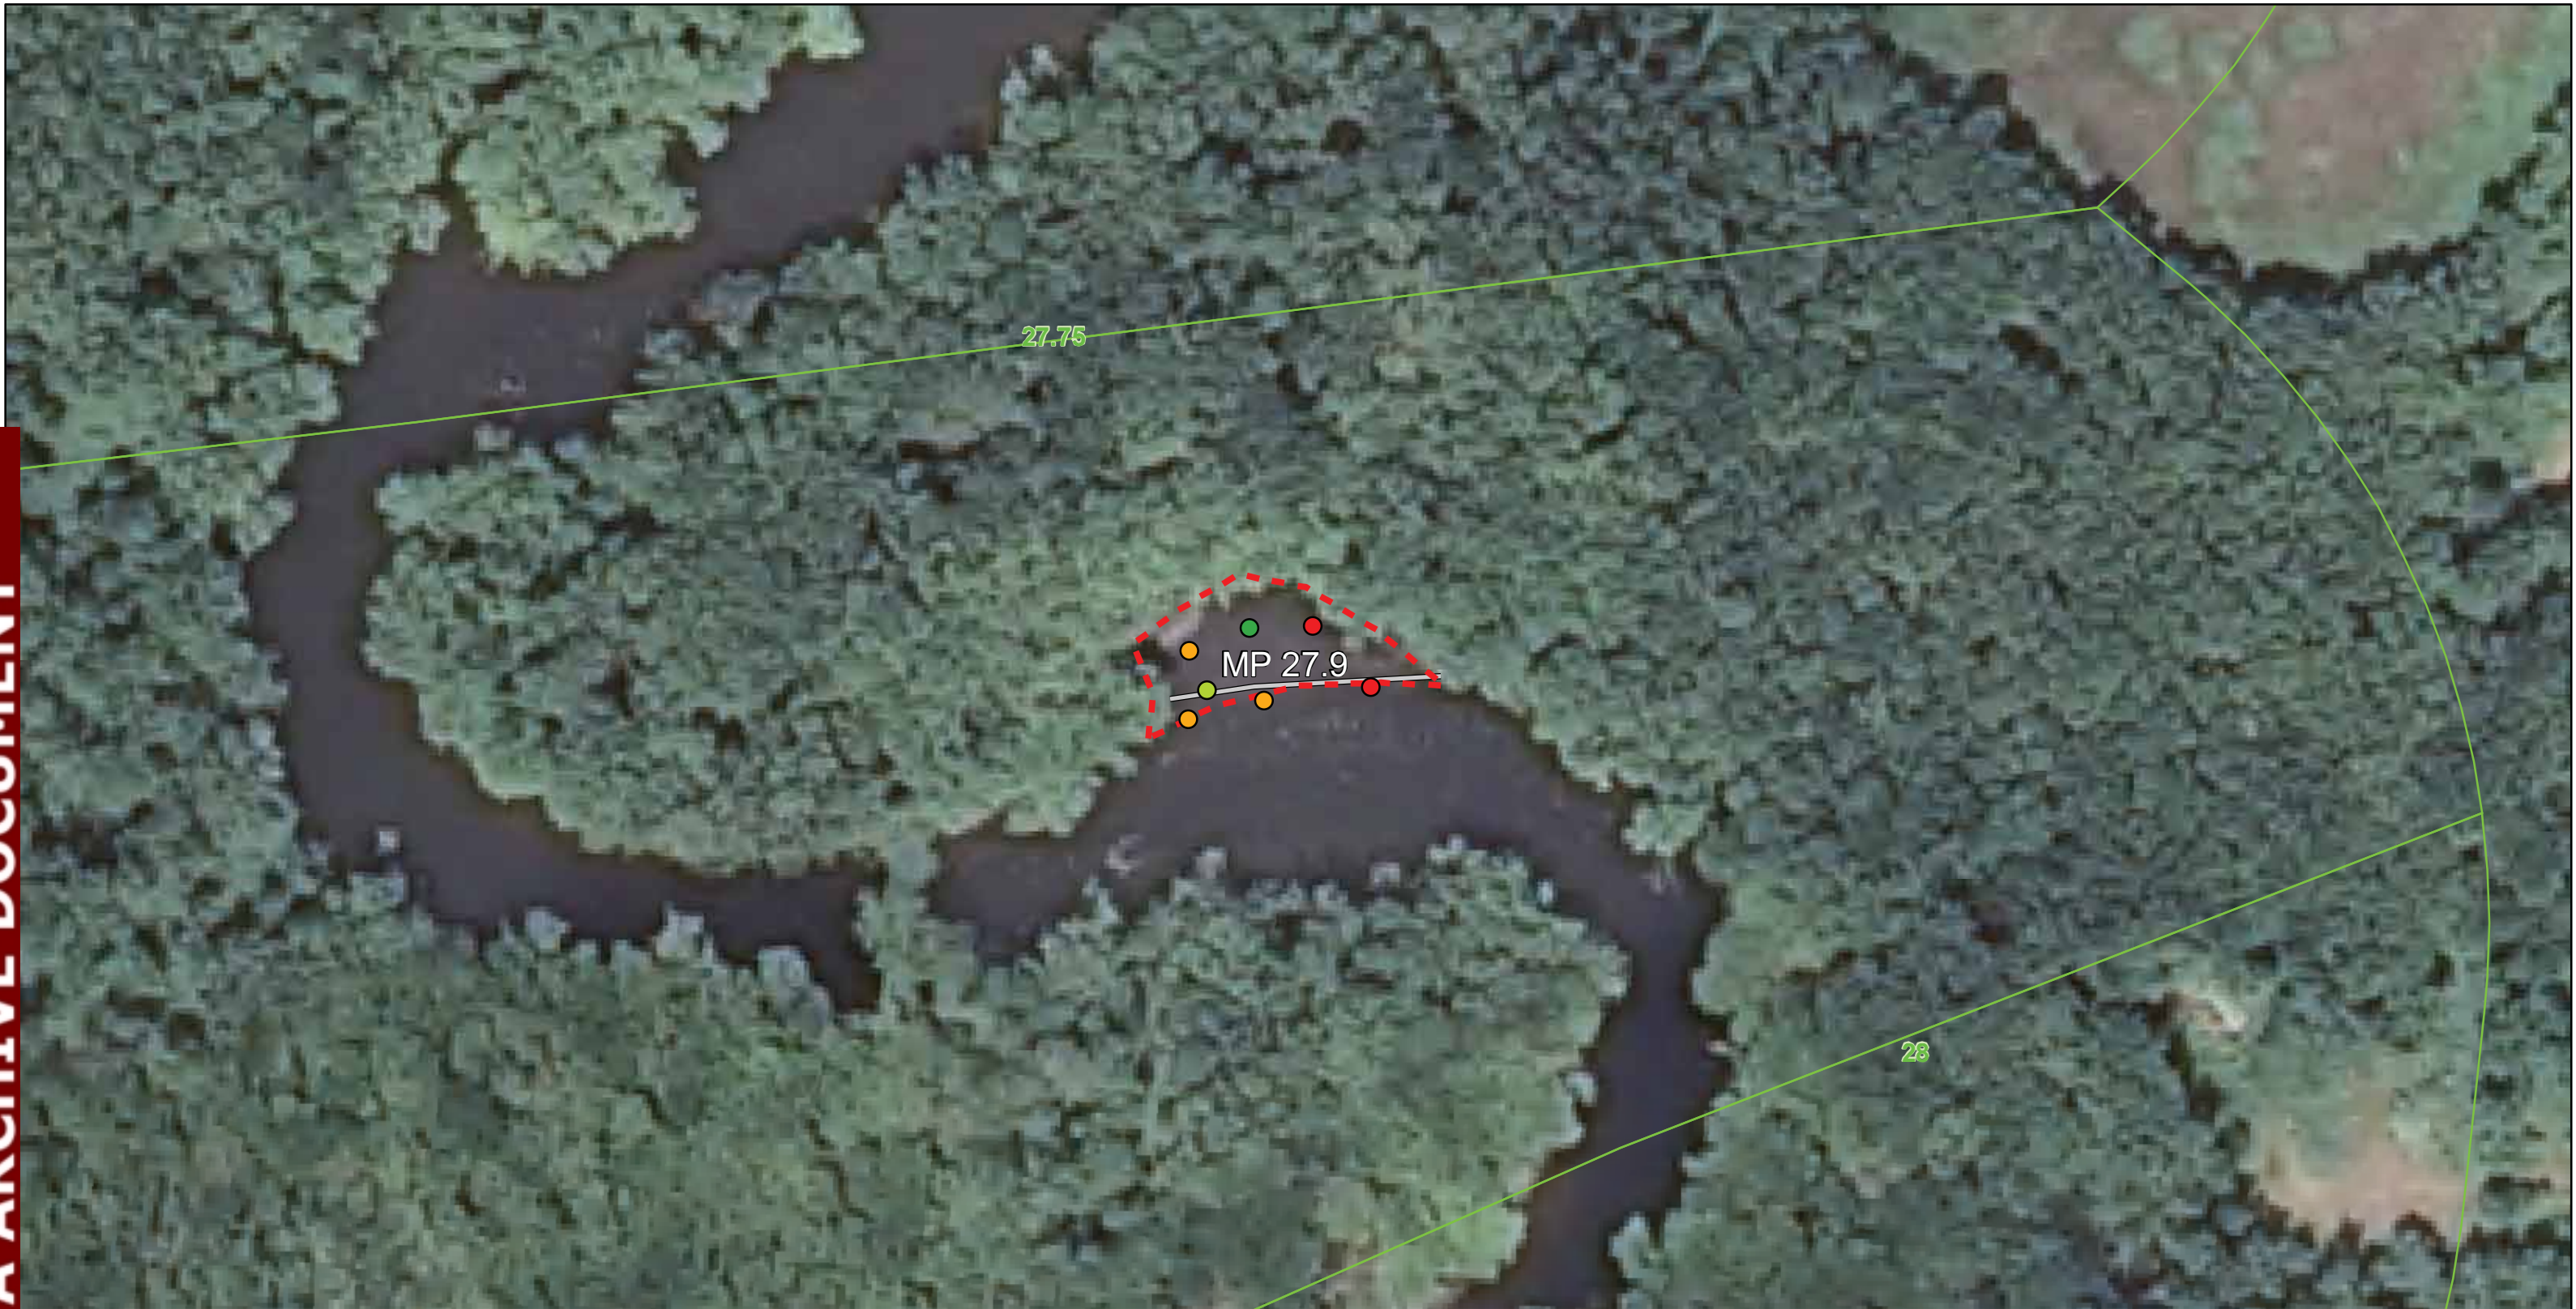
SITE SUMMARY – MP 27.90

Site Location:	MP 27.90
Site Layout:	See Figure Attached
Description and Geomorphic Setting:	Meander with depositional bar; mudflat area on right side looking downstream N42 20.467 W85 20.156
Approximate Areal Extent:	0.75 acres
Approximate Depth of Water:	0.5 feet
Sediment thickness:	0 to 1 feet
Bed type:	Soft sediment
Data Collected:	
Poling (Y/N)	Y
Cores (Y/N)	Y
Lab analysis (Y/N)	Y
Community Description and Habitat Quality:	Unvegetated mudflat; narrow scattered fringe of willows abruptly transitioning to palustrine forest dominated by mature silver maple. Fish noted in margins along the river's edge (juvenile largemouth bass and minnows).
Containment:	200' hard boom, 200' X-Tex
Access Issues:	Easy
Miscellaneous:	N/A
Recommendations:	ECO: No major environmental concerns. This area receives continual deposition of sediments, so spot dredging would be acceptable if required. SOTF: Recommend that reasonably aggressive steps be taken to remove the oil. The technique employed would rely primarily on aeration, but may also include sediment skimming, flushing, raking or a combination of these.

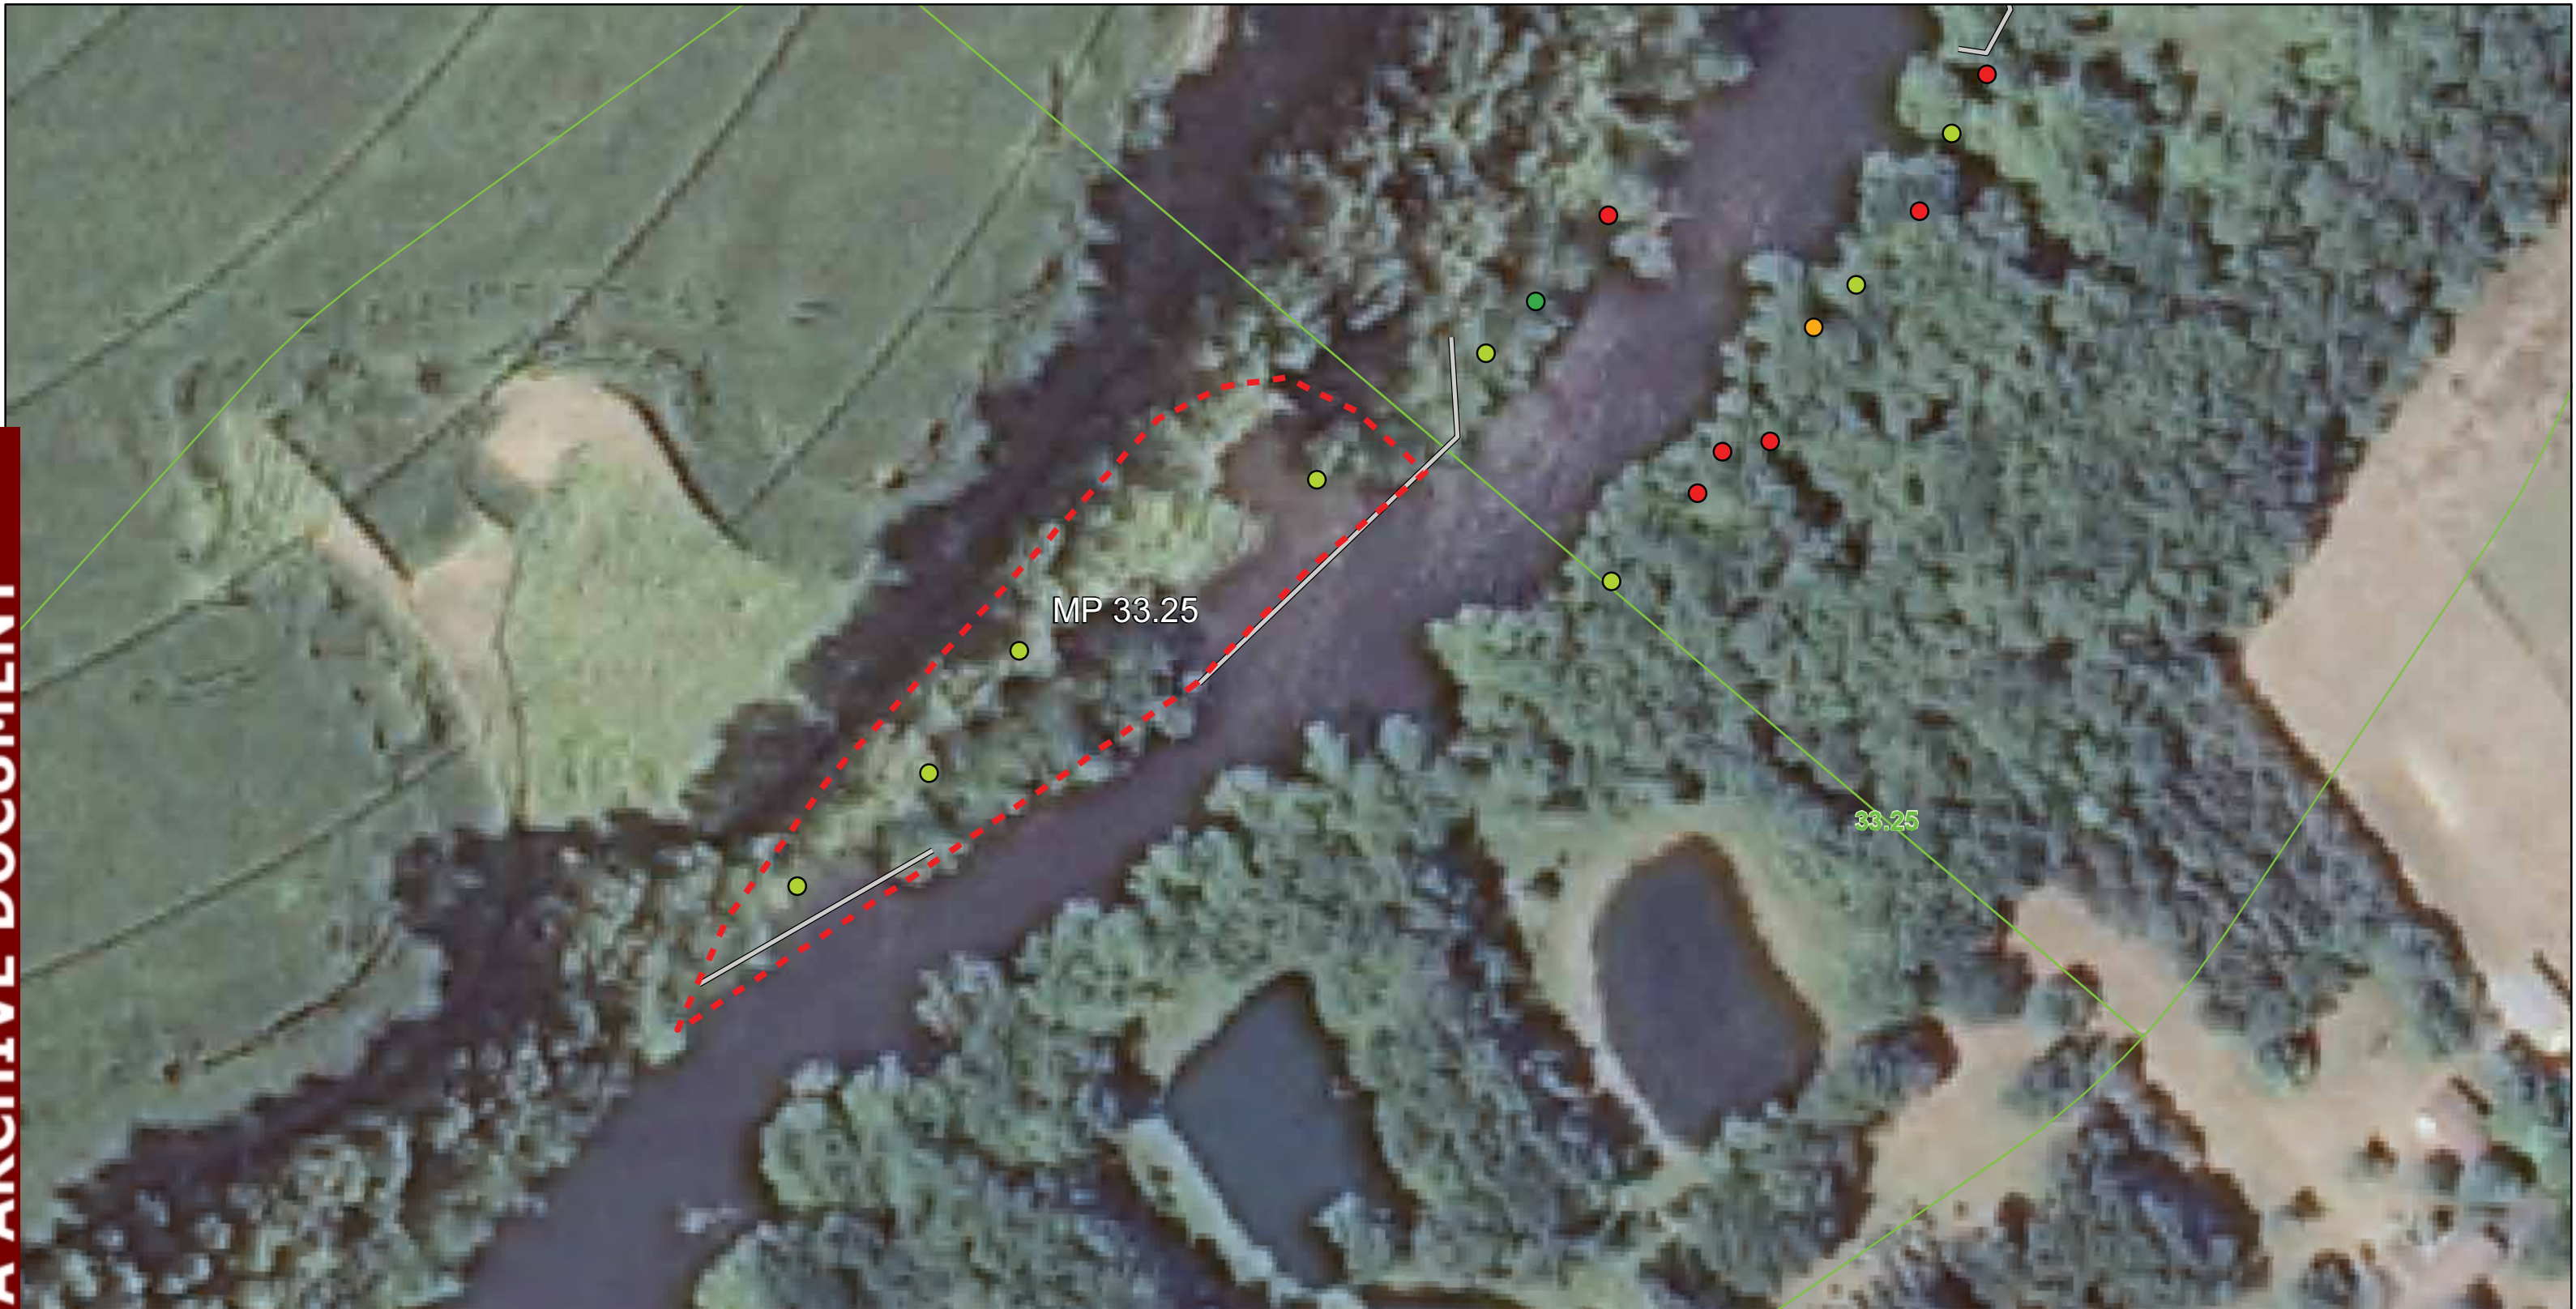
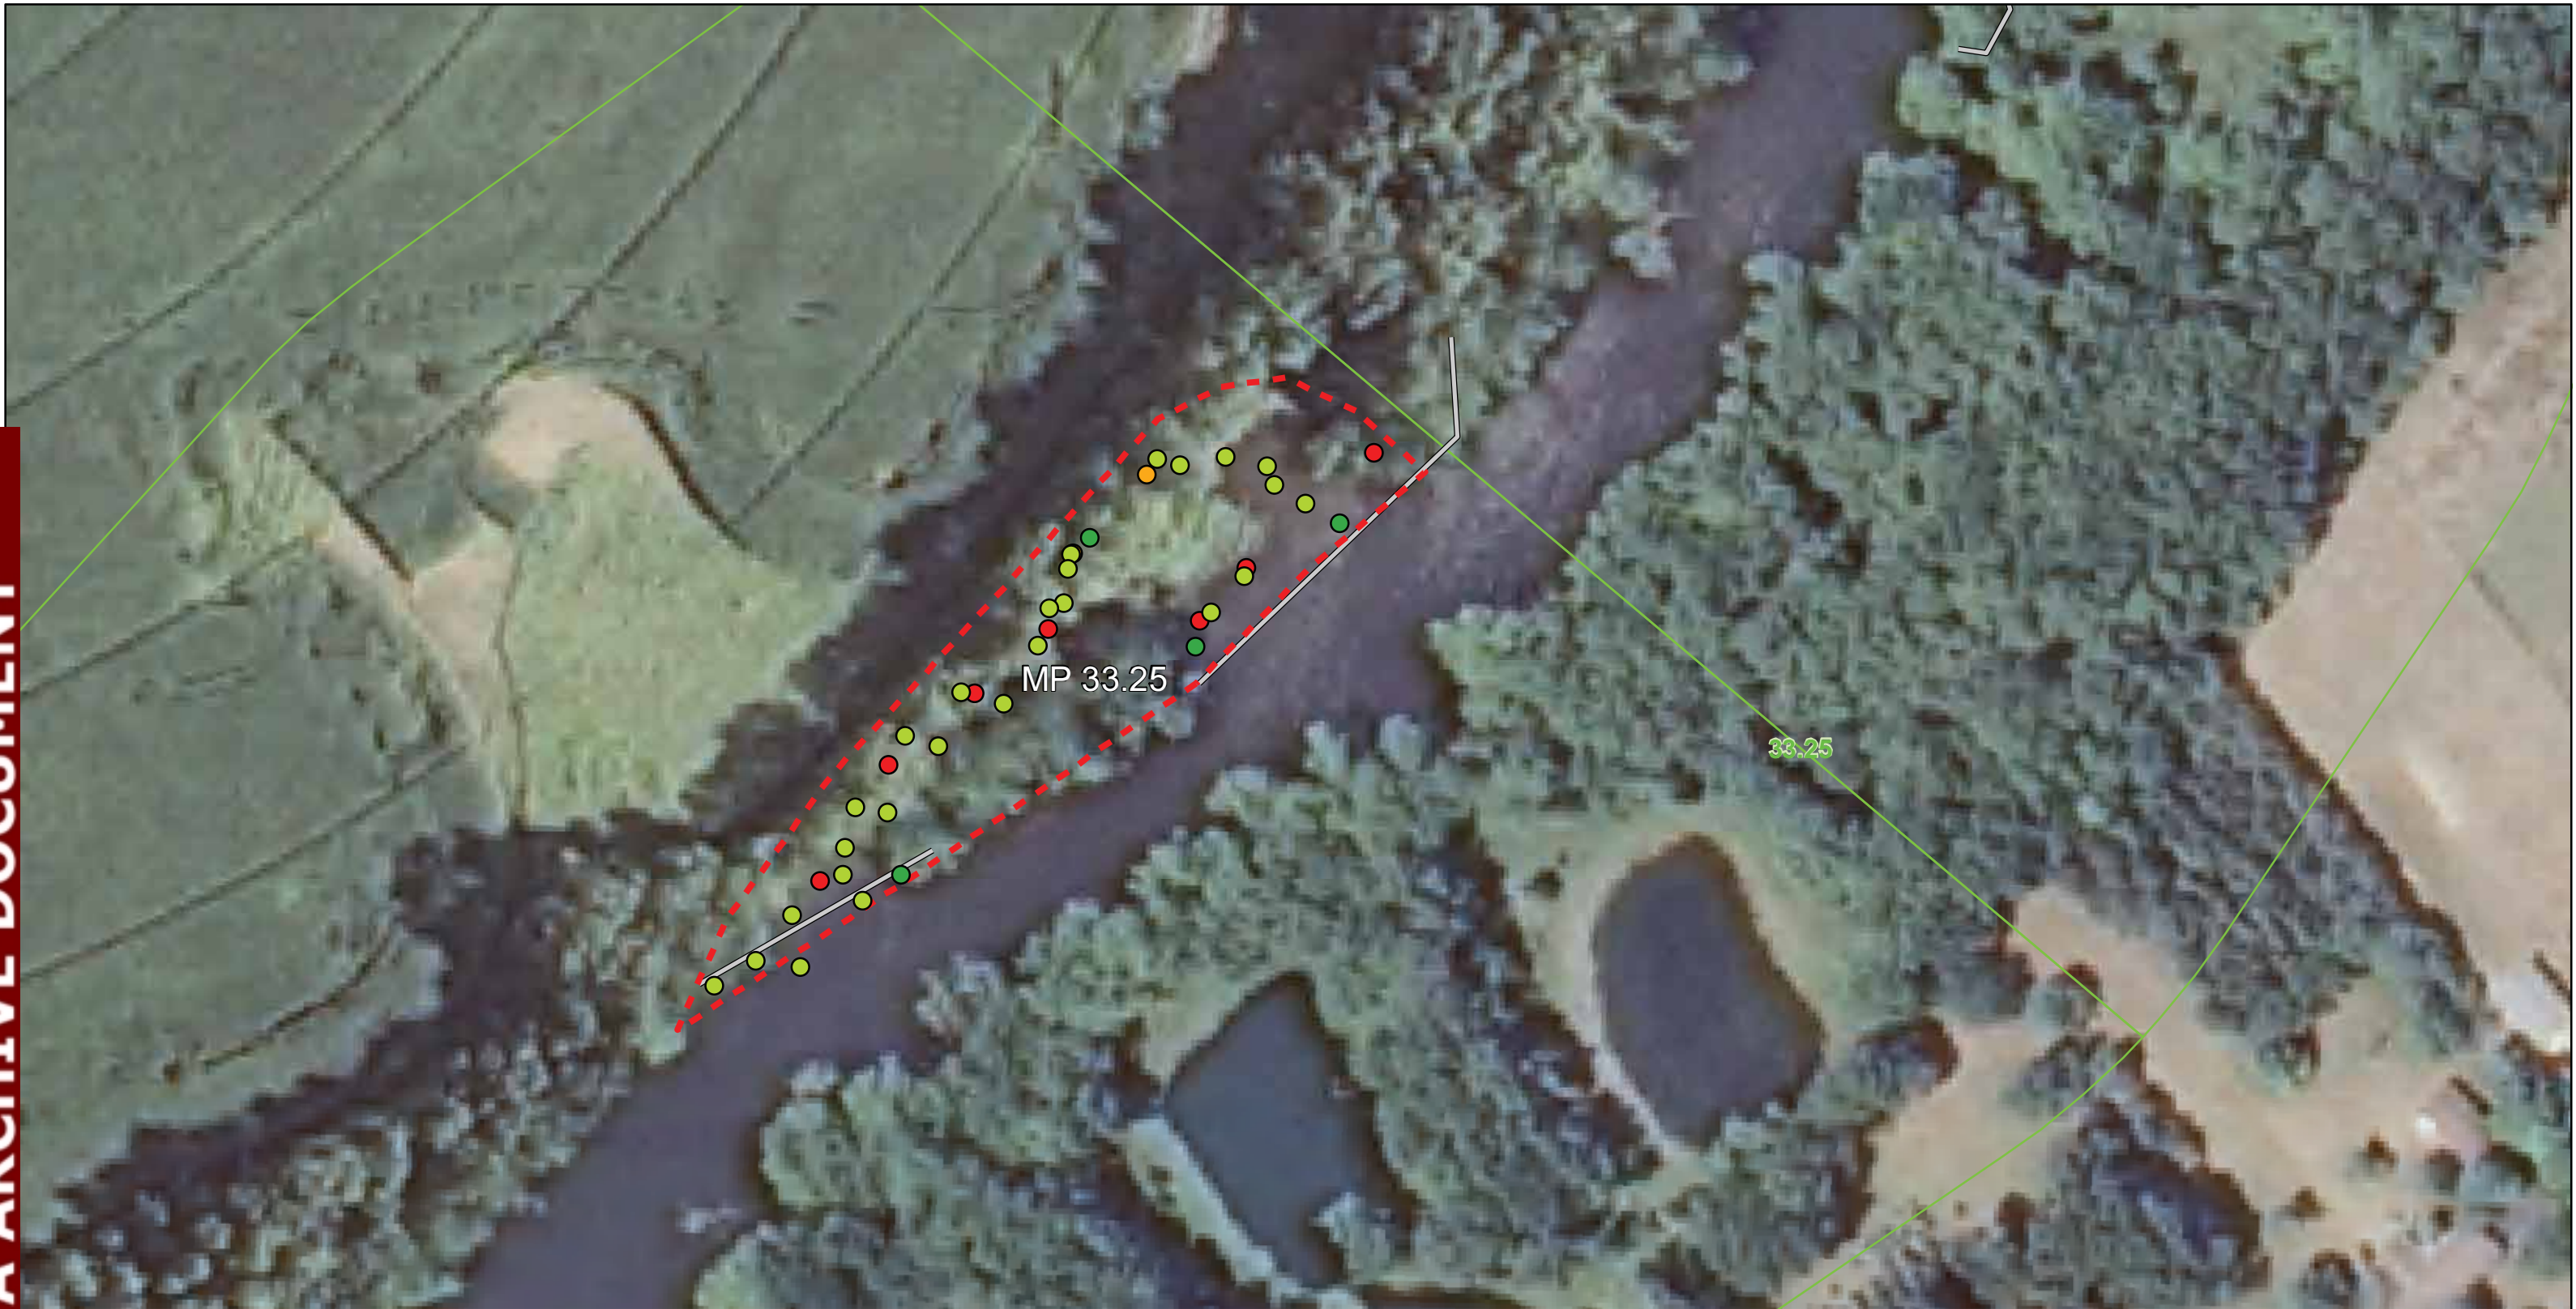
Site Location:	MP 33.25
Site Layout:	See Figure Attached
Description and Geomorphic Setting:	Backwater channel on the right side looking downstream, with island.
Approximate Areal Extent:	0.75 acres
Approximate Depth of Water:	Unknown
Sediment thickness:	0.5 to 1.5 feet
Bed type:	Soft Sediment over sand
Data Collected:	
Poling (Y/N)	Y
Cores (Y/N)	Y
Lab analysis (Y/N)	Y
Community Description and Habitat Quality:	Backwater channel is open water and shallow, with no vegetation, overlying silty bottom. Tiny juvenile fish observed. Surrounded by palustrine forest dominated by silver maple.
Containment:	500' total hard boom, 500' total X-Tex
Access Issues:	Easy to moderate
Miscellaneous:	N/A
Recommendations:	ECO: No major environmental concerns. Could stand disturbance to the channel itself, similar to other shallow coves on the river. SOTF: Recommend that reasonably aggressive steps be taken to remove the oil. The technique employed would rely primarily on aeration, but may also include sediment skimming, flushing, raking or a combination of these.

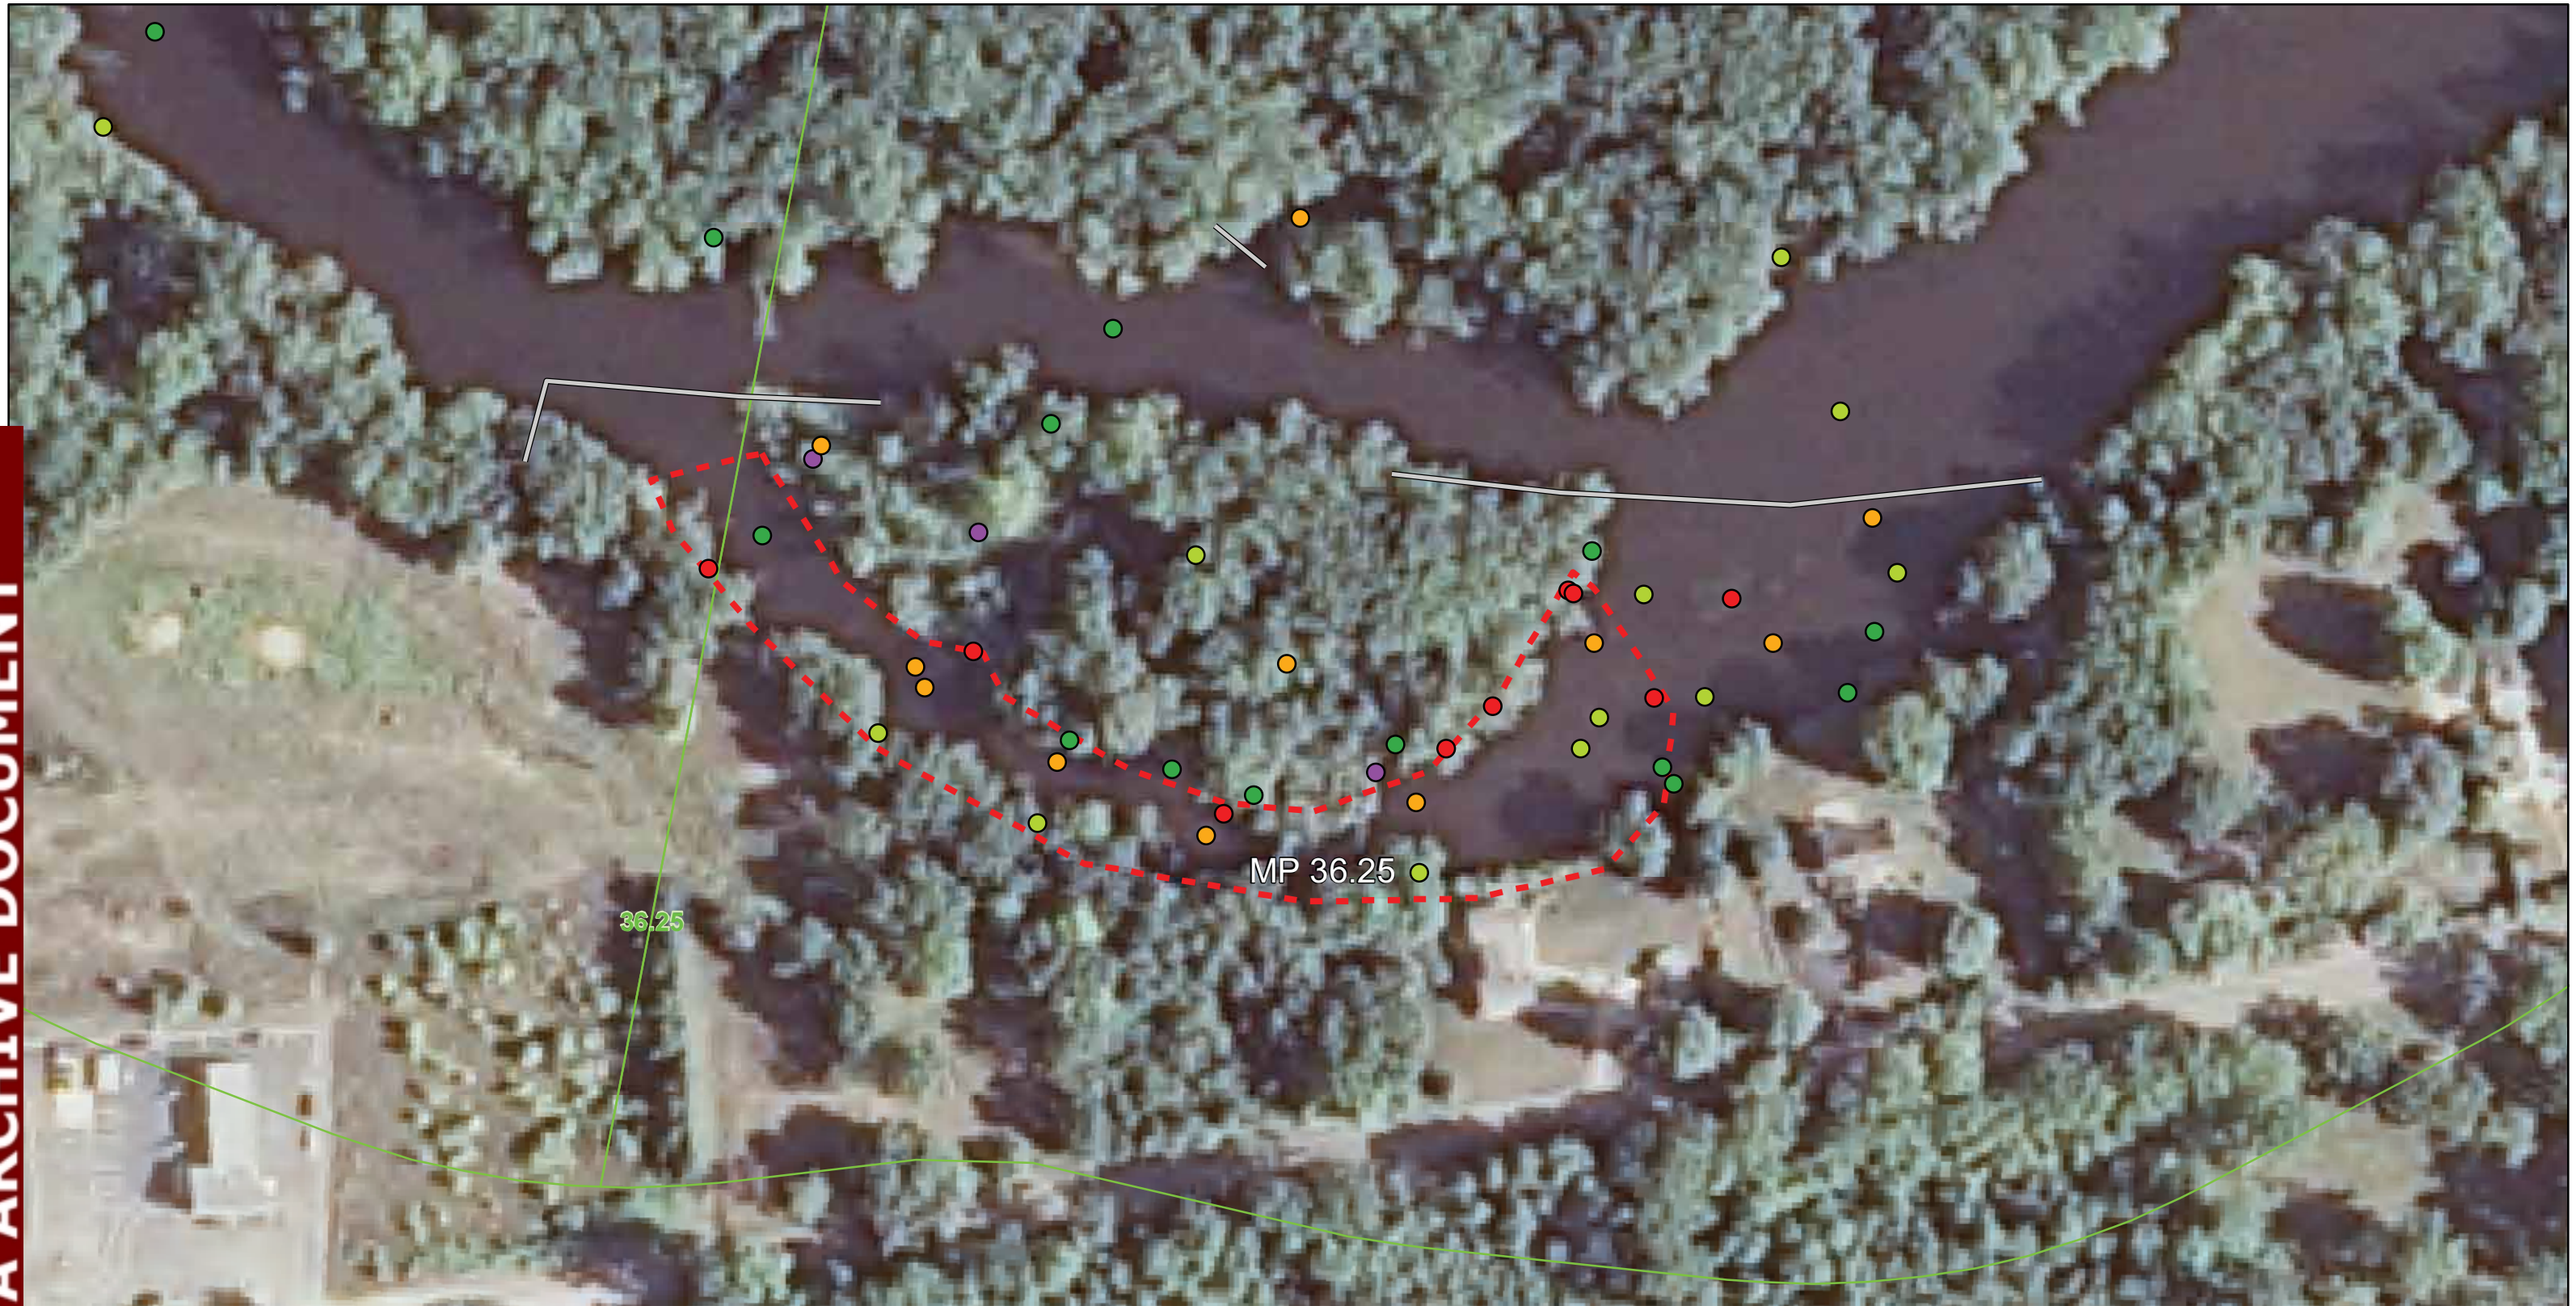
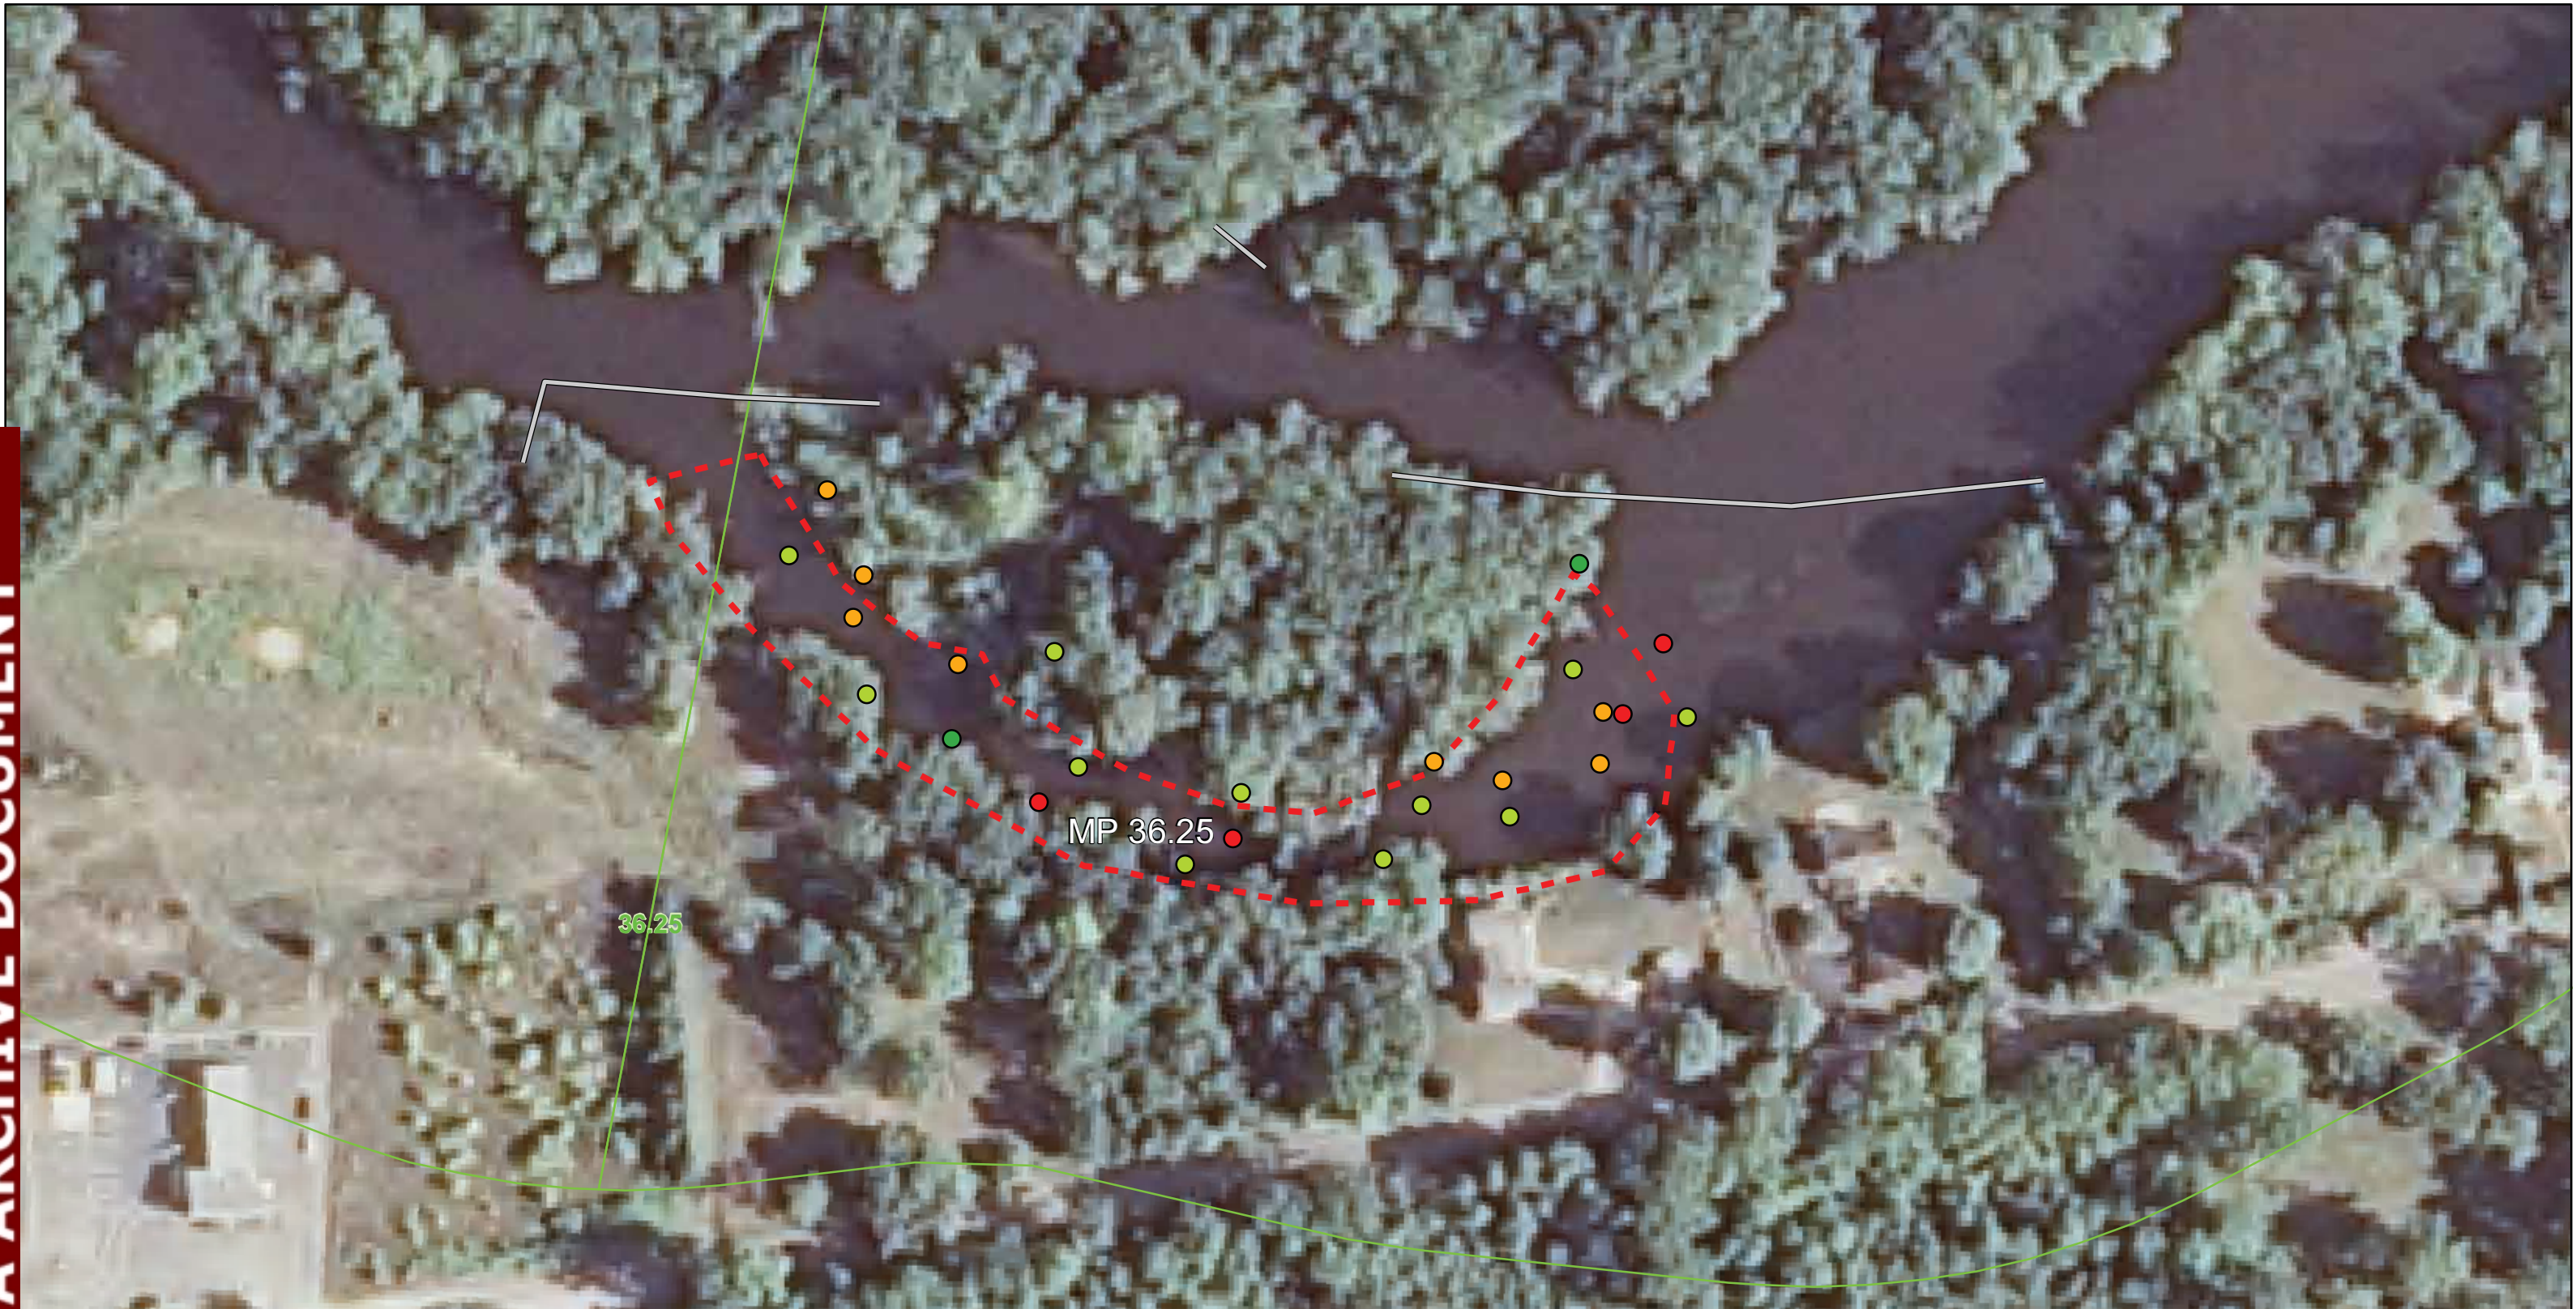
Site Location:	MP 36.25
Site Layout:	See Figure Attached
Description and Geomorphic Setting:	Cut-off meander
Approximate Areal Extent:	~ 1.33 acres
Approximate Depth of Water:	1 – 3 feet
Sediment thickness:	0.5 – 1.5 feet
Bed type:	Soft sediment over sand
Data Collected:	
Poling (Y/N)	Y
Cores (Y/N)	Y
Lab analysis (Y/N)	Y
Community Description and Habitat Quality:	
Containment:	
Access Issues:	Trees block channel where it narrows
Miscellaneous:	Wetlands on island have submerged oil but are no longer connected to river.
Recommendations:	<p>ECO: This channel will have to be dealt with carefully to avoid impacts to aquatic plants and animals. Dredging should be avoided and any re-suspension activities should avoid impacting the submerged aquatic vegetation beds and be cordoned off with a silt curtain that will minimize impacts to fish.</p> <p>SOTF: Less aggressive invasive action at this time. Cautious raking and/or flushing, taking care to avoid damage to existing vegetation. Recommend that oil containment boom around these areas be reconfigured to allow maximum water flow into and out of these areas and that downstream collection be adequately maintained to capture potential releases.</p>
